**Installation Restoration Program
Phase II - Confirmation/Quantification
Stage 1**

Seymour Johnson Air Force Base, NC 27531

July 1985

Prepared by
Center for Environmental Measurements
Research Triangle Institute
Research Triangle Park, NC 27709

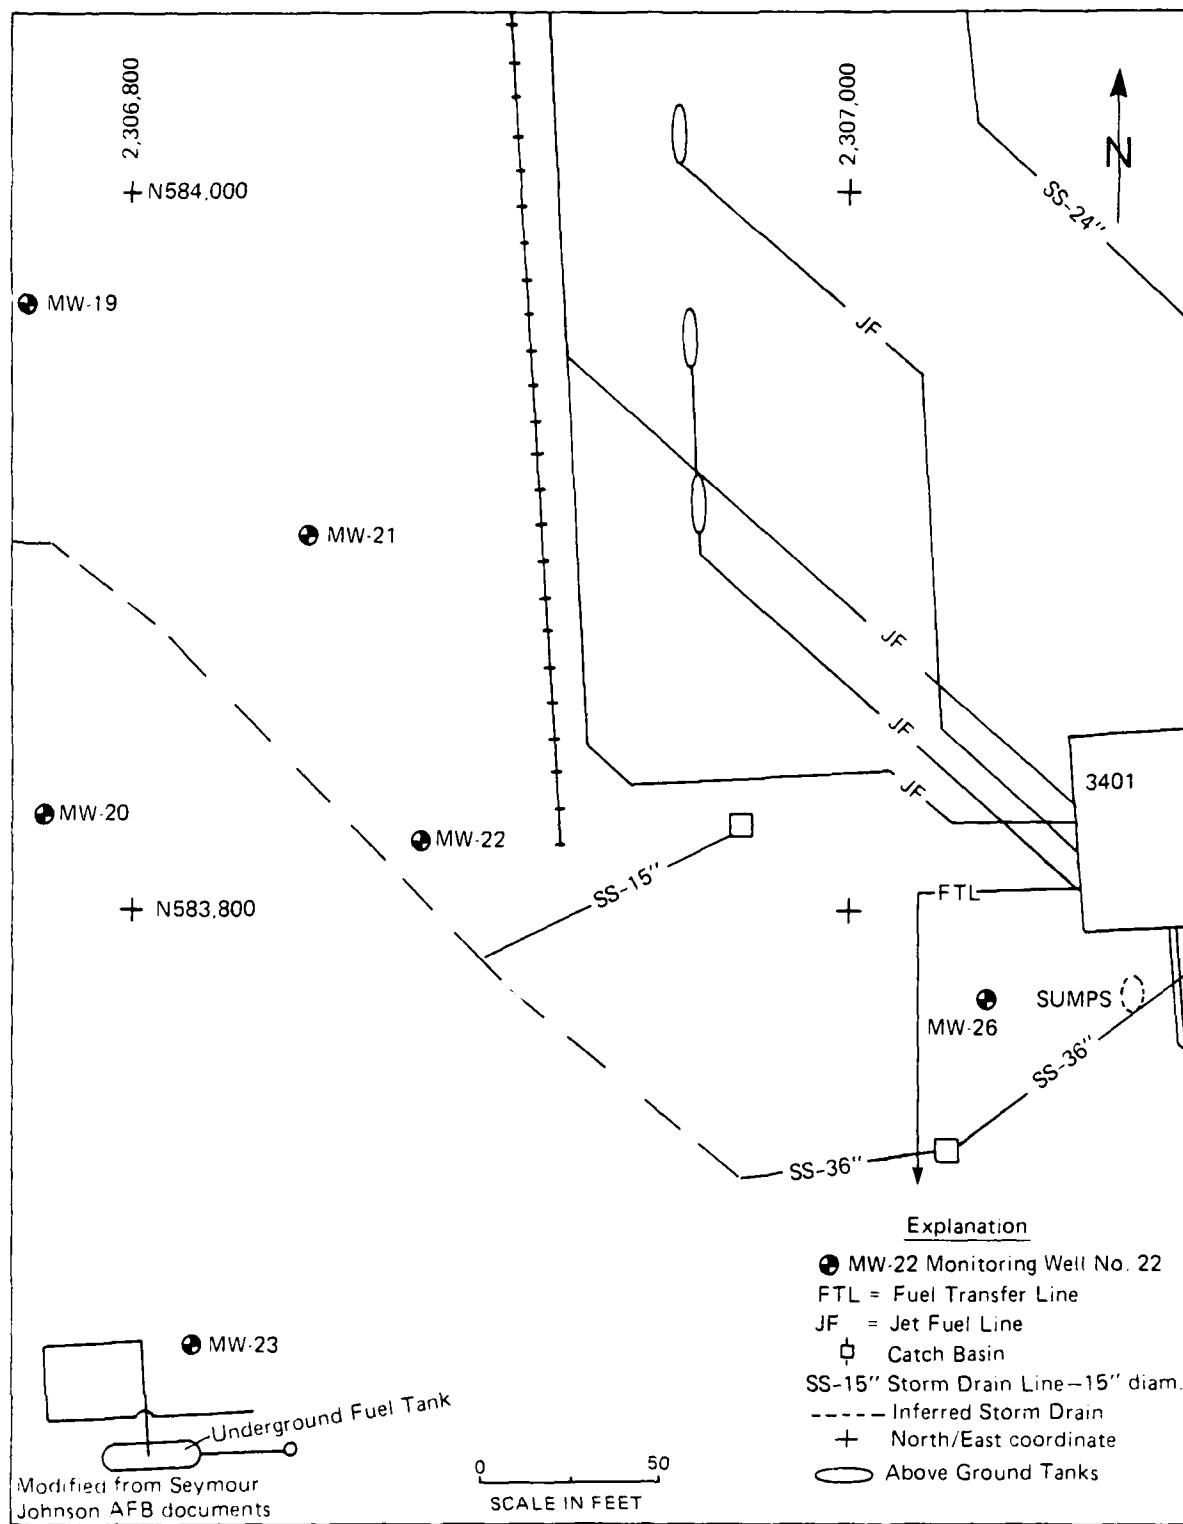
Figure 3. Location of Site 1 (tank farm fuel line leak).

(building 3401) is fed by a variety of underground fuel pipelines (Figure 3). These lines serve as main fuel transfer lines or lead to underground or aboveground storage tanks.

In mid-1981, relatively pure JP-4 began to seep into a small, three foot deep, concrete sump adjacent to the tank farm pump station. Excavation of the immediate area to a 4-foot depth revealed no source for this fuel. Pressure testing of pump station piping indicated no apparent leaks. During backfilling, a 12-inch diameter steel pipe was placed vertically next to the sump to provide a means of recovering JP-4 on a regular basis. The fuel level varies from 1 to 3 feet below the ground surface and, reportedly, fluctuates with rainfall. The average thickness of the fuel layer is 3 to 4 feet.

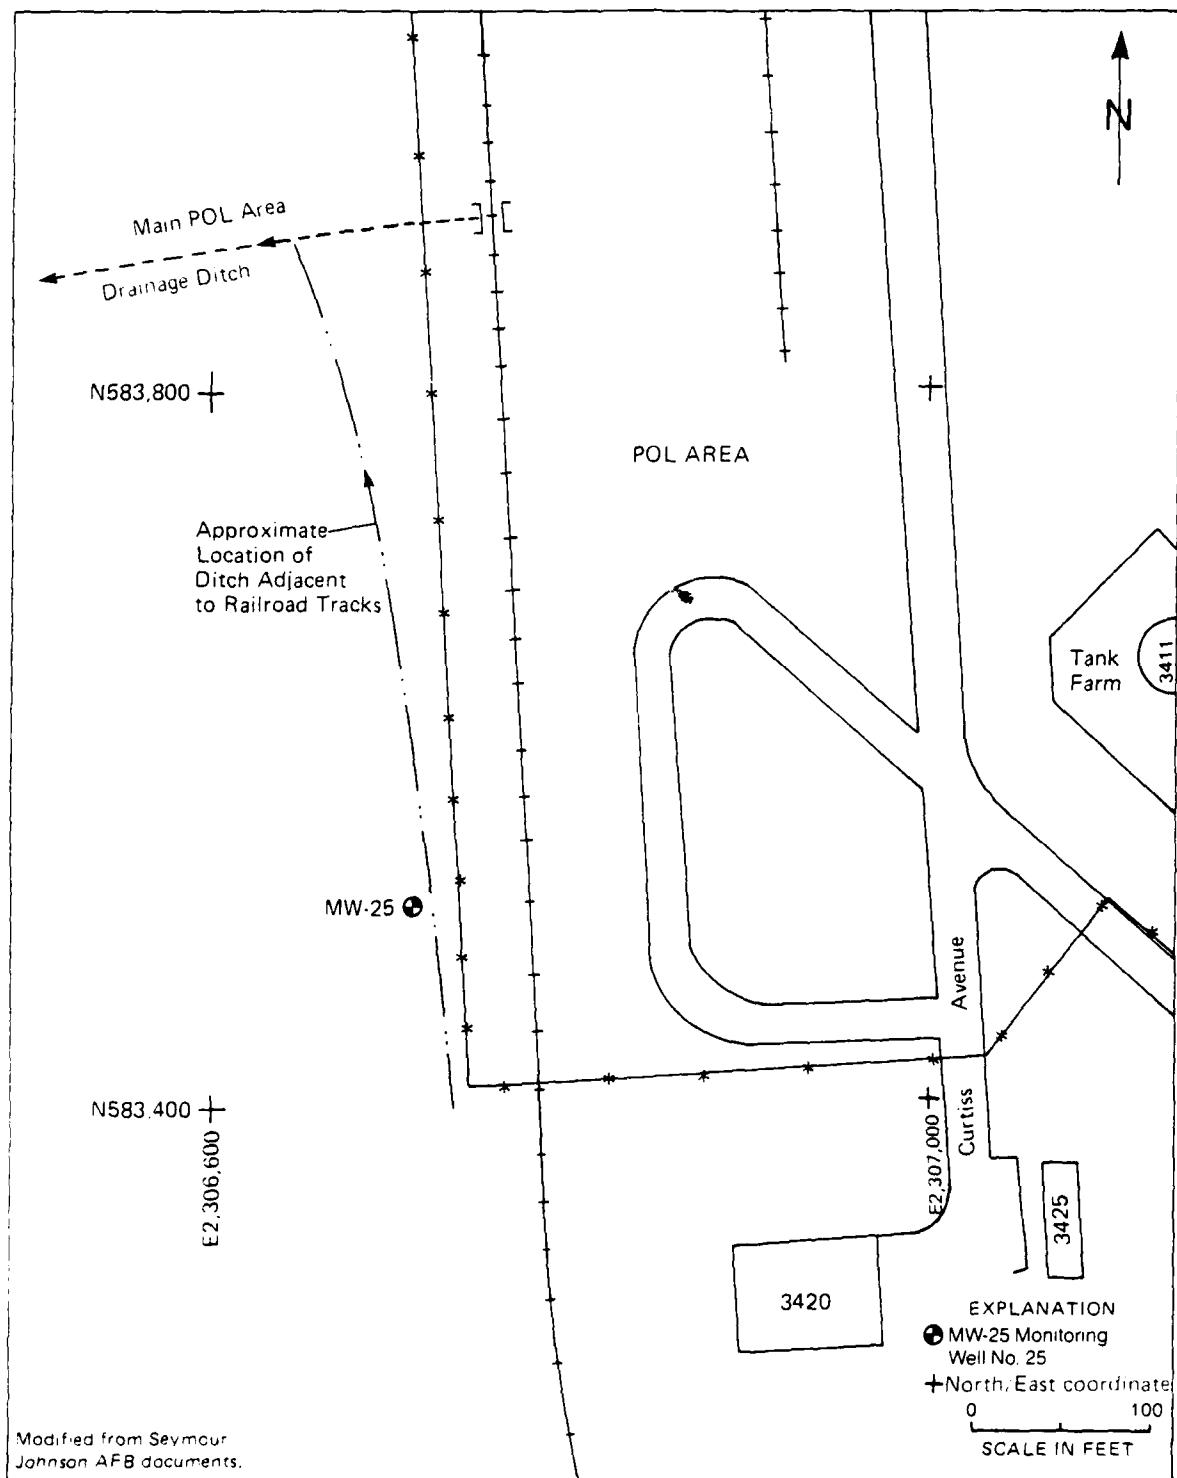
Figure 4. Location of Site 2 (ditch adjacent to railroad tracks).

The location of Site 2 is indicated in Figure 4. The ditch trends roughly north-south and parallels the fence and railroad tracks that bound the western portion of the POL area. The ditch drains approximately 500 feet northward into the main POL area drainage ditch (Figure 4). The north-south trending ditch is shallowest near its origin and is several feet deep at its confluence with the east-west trending drainage ditch. The purpose of the ditch adjacent to the railroad tracks is to intercept petroleum-related products observed in the shallow subsurface.

Seepage that was covered by a dark oily film (assumed to be petroleum-related products) was observed entering both sides of the north-south trending ditch adjacent to the railroad tracks at the time of the Phase II field studies. The flow in the ditch increases to the north as additional seepage enters. Flow was observed in the ditch during each visit to the site and is believed to be associated with groundwater discharge.

In an effort to determine the groundwater quality in the vicinity of Site 2, one shallow monitoring well was installed on the west side of the ditch (Figure 4). Soil samples were collected at 3-foot depth intervals

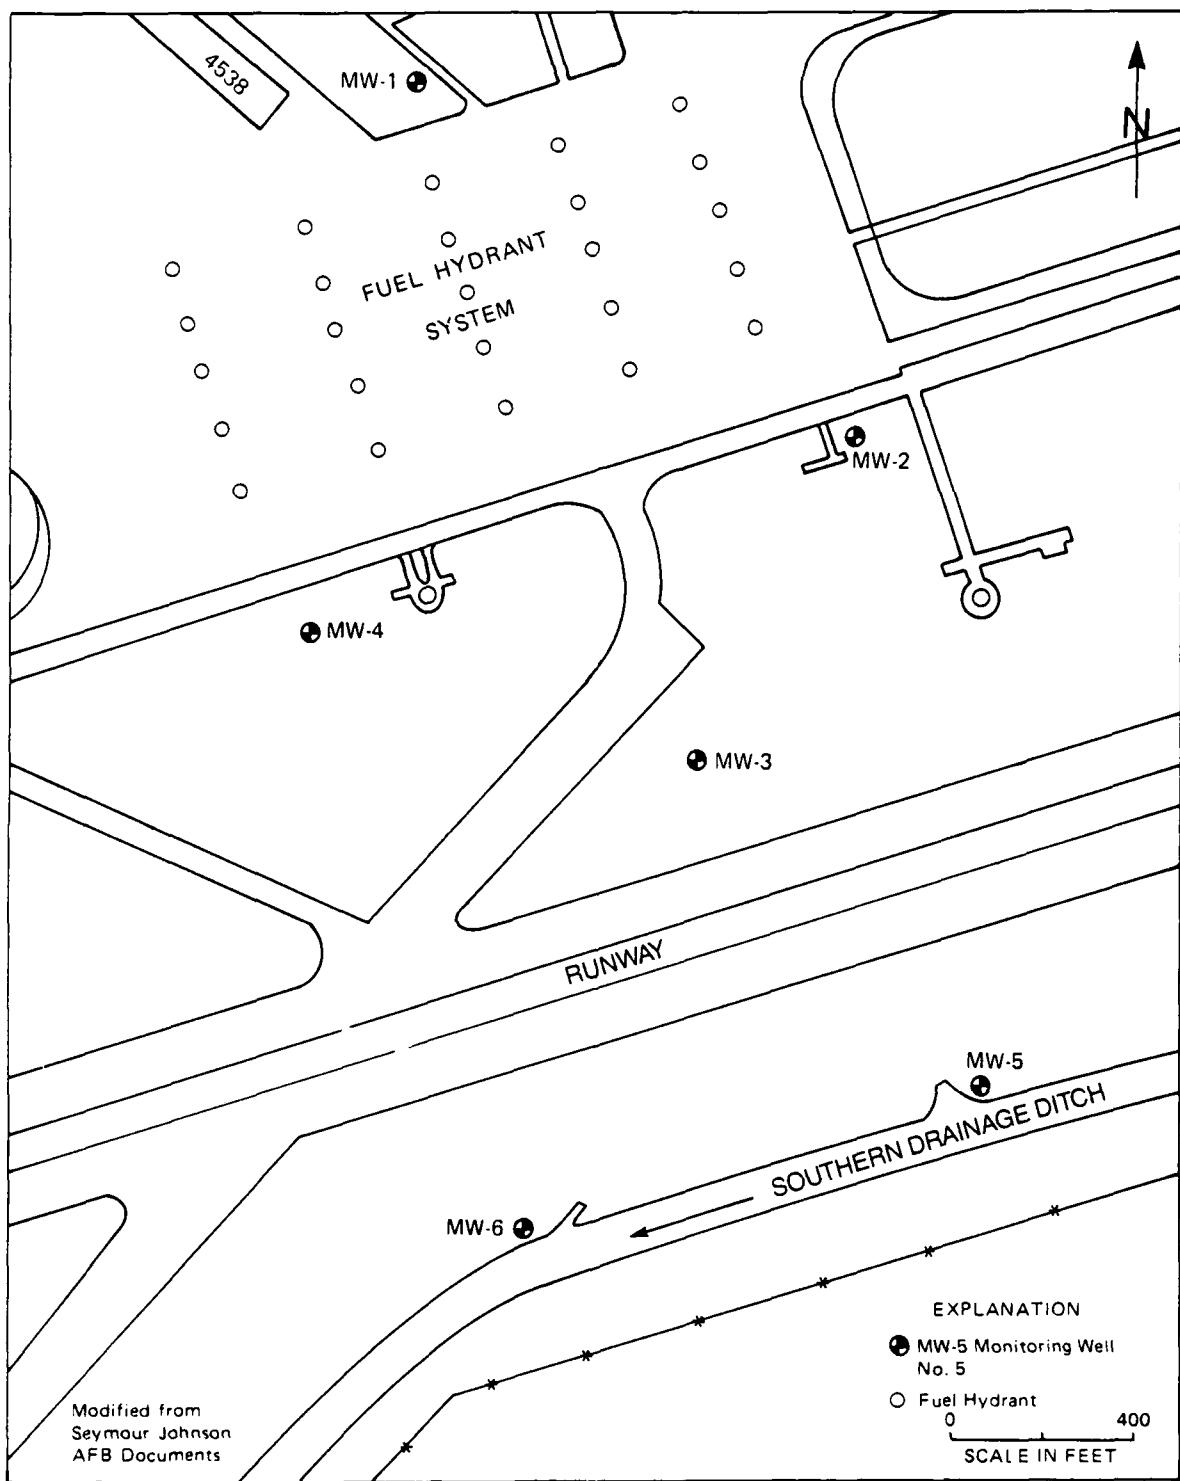
Figure 6. Location of Site 4 (fuel hydrant system leak).

The underground hydrant refueling system has developed leaks on occasion. Since 1978, leaks resulting from cathodic reaction have been detected and repaired in some laterals. The liquid fuels maintenance shop performs (at a minimum) annual pressure tests on the hydrant lines. No pressure loss has been observed; however, during vacuum defueling procedures, metal flakes and other foreign material have appeared in increased amounts in the fuel filters. This material is considered indicative of corrosion in the

system piping. JP-4 has been observed infiltrating into the storm drain at two manholes on the aircraft parking apron. It is uncertain if the source of the infiltrating fuel is an active leak or a residual that may have developed during a past leak.

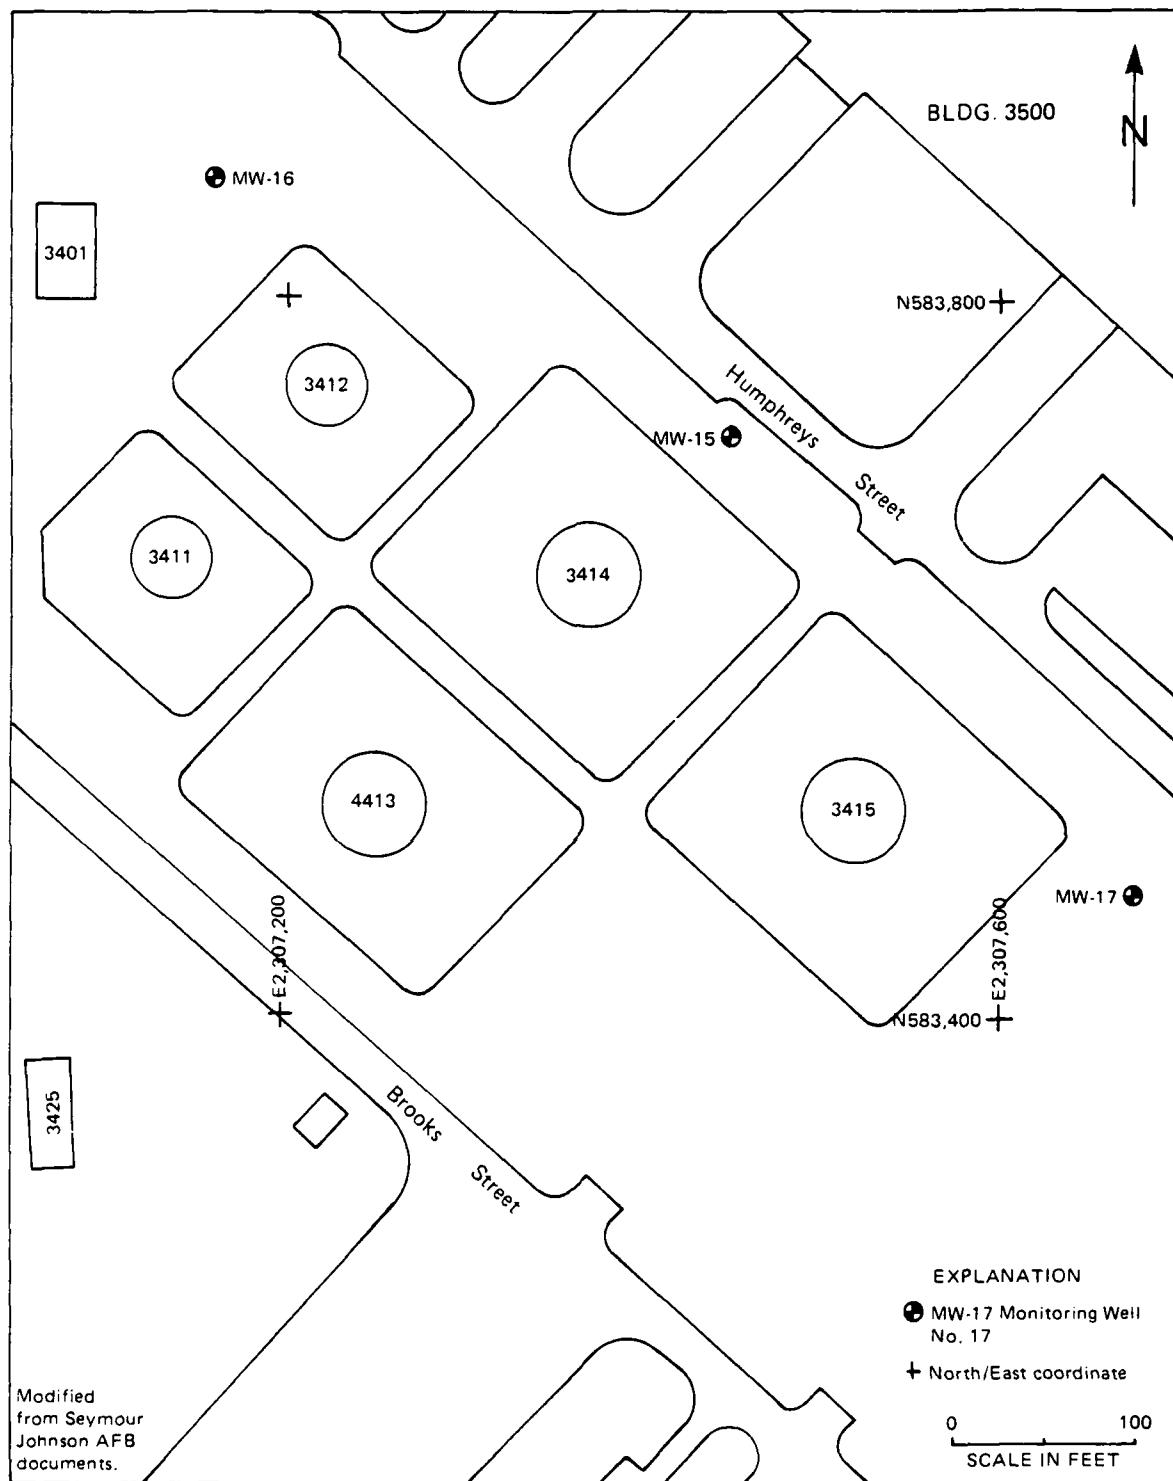
Figure 7. Location of Site 5 (tank farm fuel spill).

The location of Site 5 is indicated in Figure 7. Most of the JP-4 fuel on Base is stored at the POL tank farm in five aboveground tanks (two 420,000-gallon tanks and three 840,000-gallon tanks). In November 1980, a large fuel spill occurred at the POL tank farm when a valve stem at the base of Tank No. 3414 (also referred to as Tank No. 2) was unbolted while an associated safety valve was still open to the tank. Approximately 400,000 gallons of JP-4 were spilled and an estimated 375,000 gallons of fuel were recovered. The clay dike surrounding the tank did not overflow. After cleanup, test pits were dug in the diked area to a depth of 1 foot, and shallow wells (6 inches diameter, 3 feet deep) were dug. Little or no infiltration into the soil was detected. Rainwater collected within the dike had no significant concentration of oil and grease prior to discharge. The test pits and shallow wells were covered and filled within a few months of the spill date.

Since 1981, rainwater collected within the dike surrounding Tank No. 3414 has shown abnormally high oil and grease concentrations (580 milligrams/liter (mg/l) to 124,000 mg/l). There has been no history of fuel spillage within this dike since the November 1980 spill. No explanation for the high concentration of oil and grease has been recorded.

Three monitoring wells (each about 30 feet deep) were installed in the vicinity of Tank No. 3414 (Figure 7). The wells were set deeper than others on the Base to determine the potential vertical extent of the 1980 spill. The bottoms of each of these wells were still within the clayey sands that separate the surficial aquifer from the principal aquifer (see Section 4.9.1).

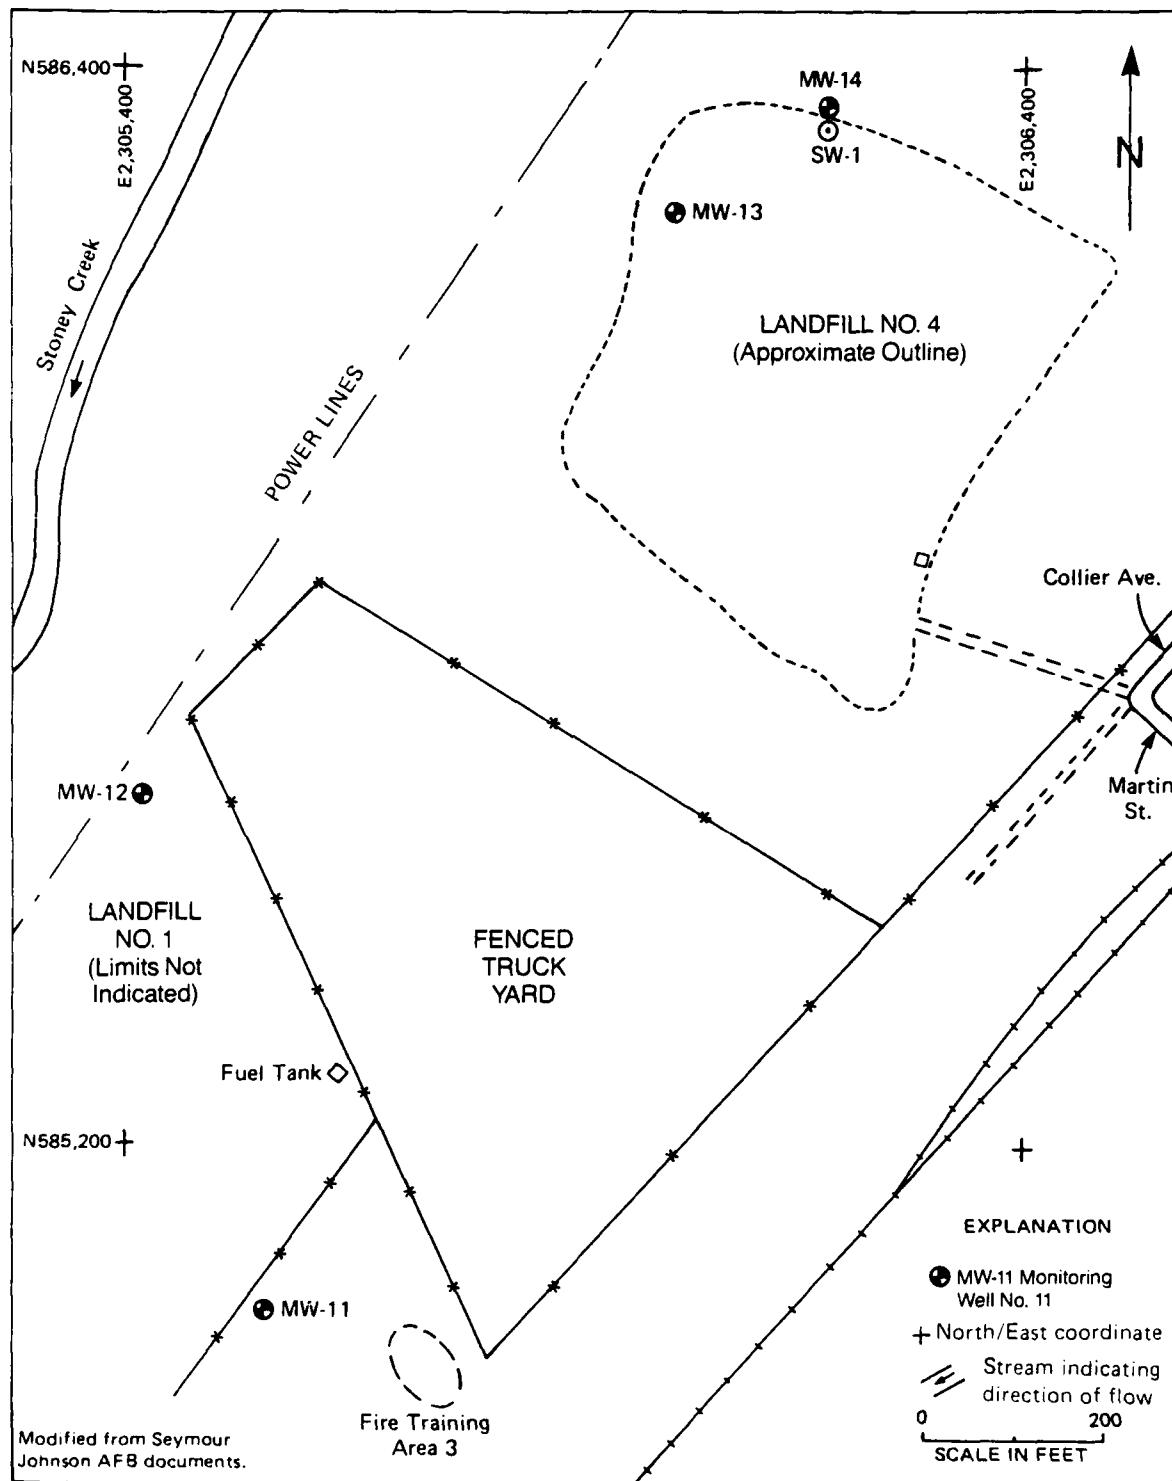
Figure 8. Location of Site 6 (fire training area 3 and landfills 1 and 4).

Leachate has been observed along the northern toe of the landfill. This leachate has been sampled (SW-1), and two monitoring wells have been installed at the landfill (Figure 8).

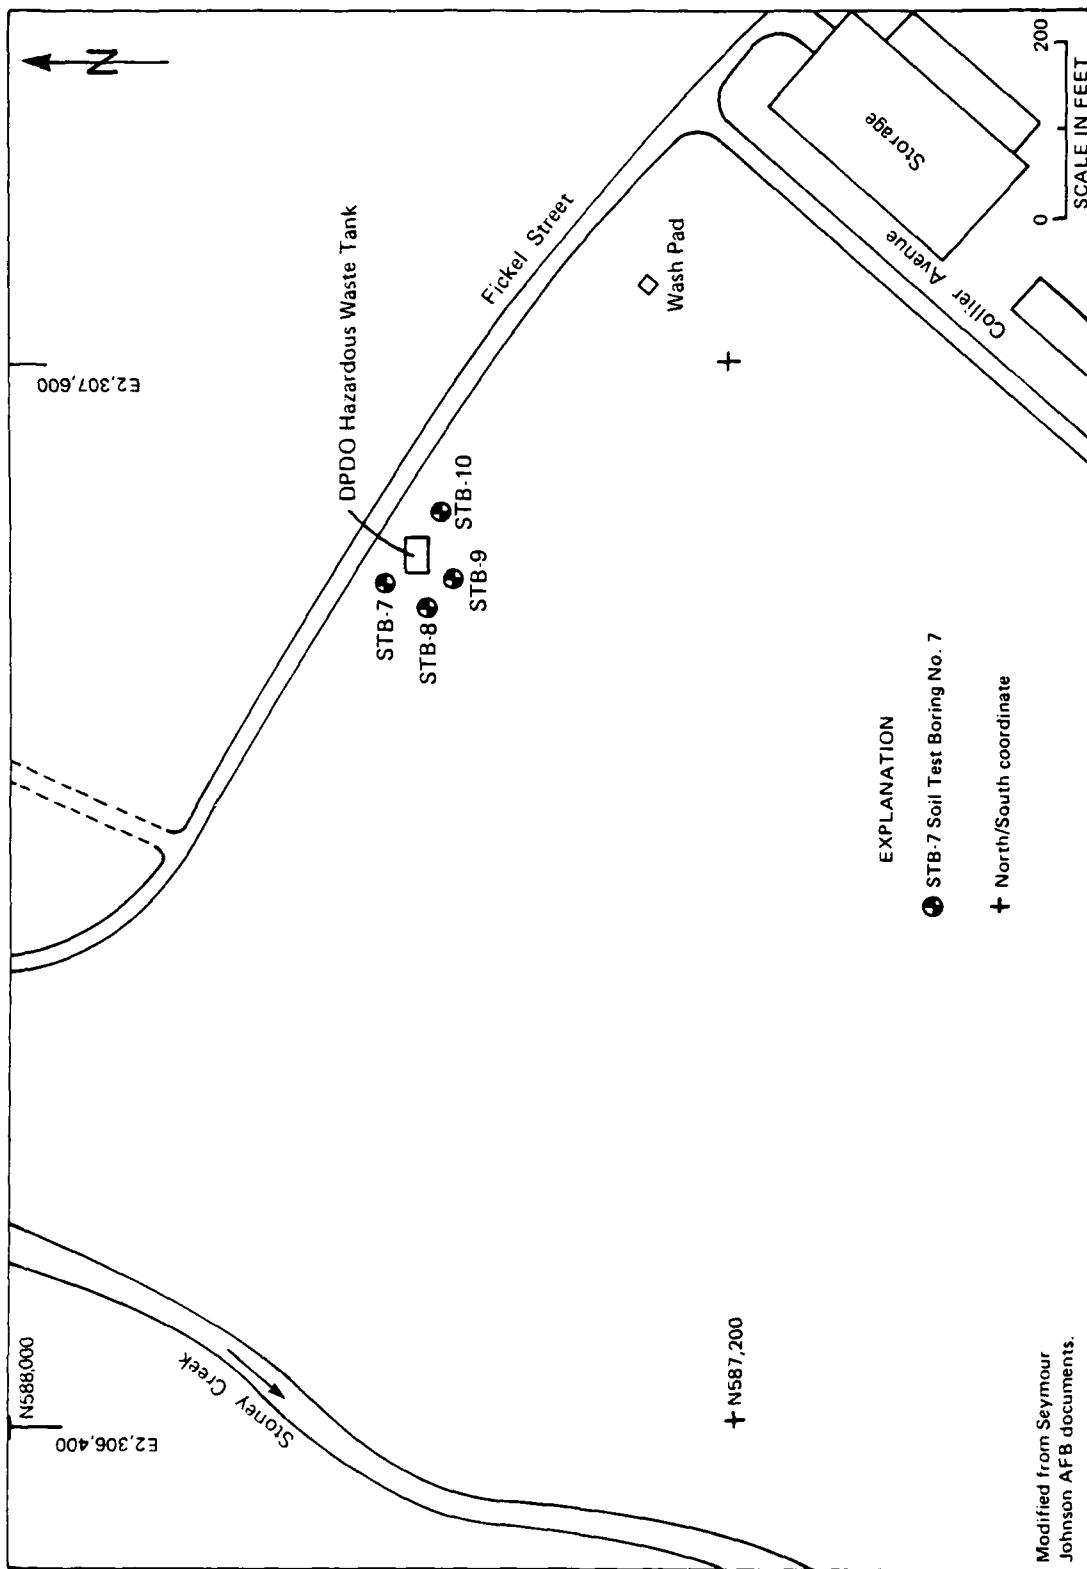
Figure 9. Location of Site 7 (DPDO hazardous waste tank).

Site 7 is located on the northern section of the Base, just south of Fickel Street (Figure 9). The area is enclosed by a fence but is not paved. No known spills have occurred from the site. There are also no

obvious indications of spills on the ground surface. Barrels stored at the site have appeared to be intact. An underground storage tank exists at the site and is used to store commingled POL waste products. Pesticides and waste solvents have also been stored at the site.

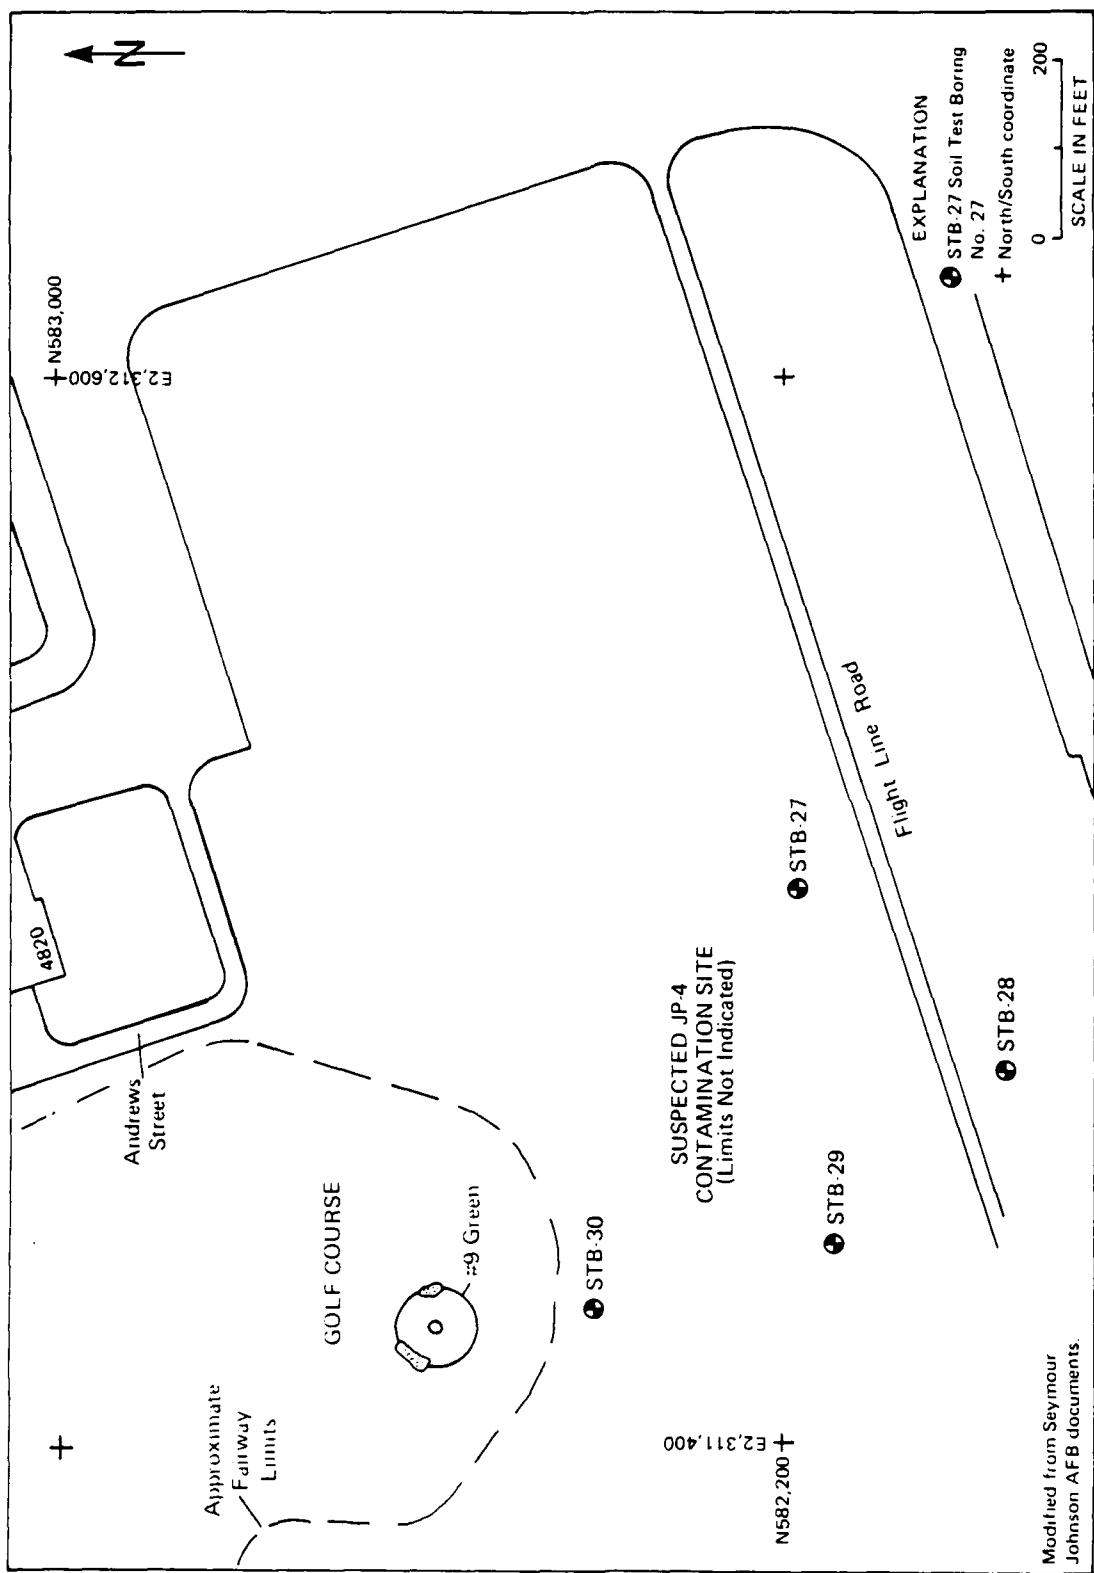
Figure 10. Location of Site 8 (suspected JP-4 contamination site).

Site 8 is located in the central portion of the Base between the flight line road and Building 4820 (Figure 10). The site is adjacent to a golf course and is used occasionally for troop practice areas. The site was suspected by some of having JP-4 contamination from observations of discolored seepage that migrated to the ground surface during periods of rainfall.

Four soil test borings were drilled at Site 8 to depths of about 15 feet (Figure 10). Soil samples were collected for analysis, but no monitoring wells were installed in the borings. The borings were backfilled with soil and grouted at the land surface.

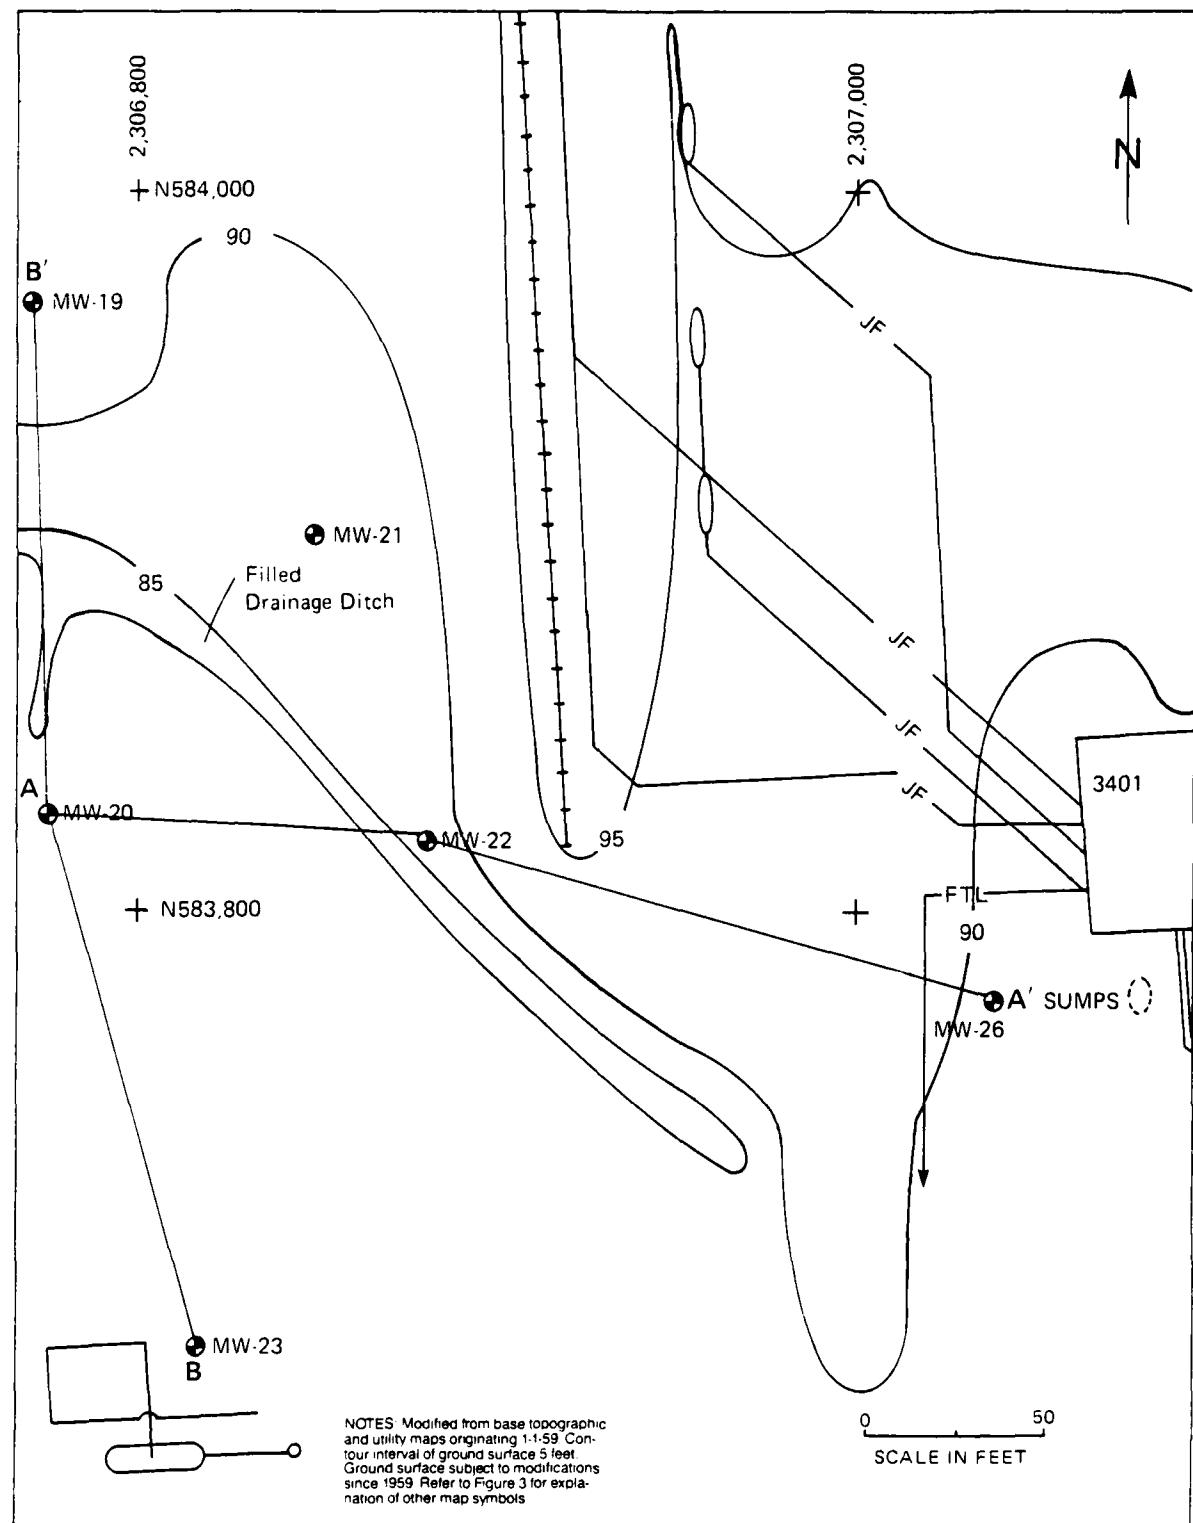
Figure 16. Topographic setting of Site 1 with location of inferred hydrogeologic profiles A-A' and B-B'.

The topographic setting of Site 1 is indicated in Figure 16. Site 1 is presently a nearly flat-lying area with some slope to the west. According to the Base topographic and utility maps (originating January 1959), the area was previously drained by a northwest-trending drainage ditch (Figure 16). Storm drains in this area, shown on the 1959 Base topographic and utility map, suggest a hydraulic connection between this localized storm drainage and the filled drainage ditch. This system drains to the northwest.

Six monitoring wells were installed at the site. Two inferred hydrogeologic profiles have been constructed using five of these wells (Figures 17 and 18). Several feet of fill materials have been placed in some areas of Site 1 (Figure 17). Where encountered, these materials consist of black clayey sand with some root material (Appendix C). Silty sands with a wide textural variation underlie the fill, where encountered. The silty sand strata have an average thickness of about 6 feet at the site. The sands are significantly coarser grained with layers of clayey sand at well MW-23 (Figure 18) and may represent a channel deposit within the surficial deposits. The estimated yield of well MW-23 (6 to 8 gal/min) was also significantly higher than in other wells at the site (less than 1 gal/min), indicating a localized geologic feature in the vicinity of well MW-23.

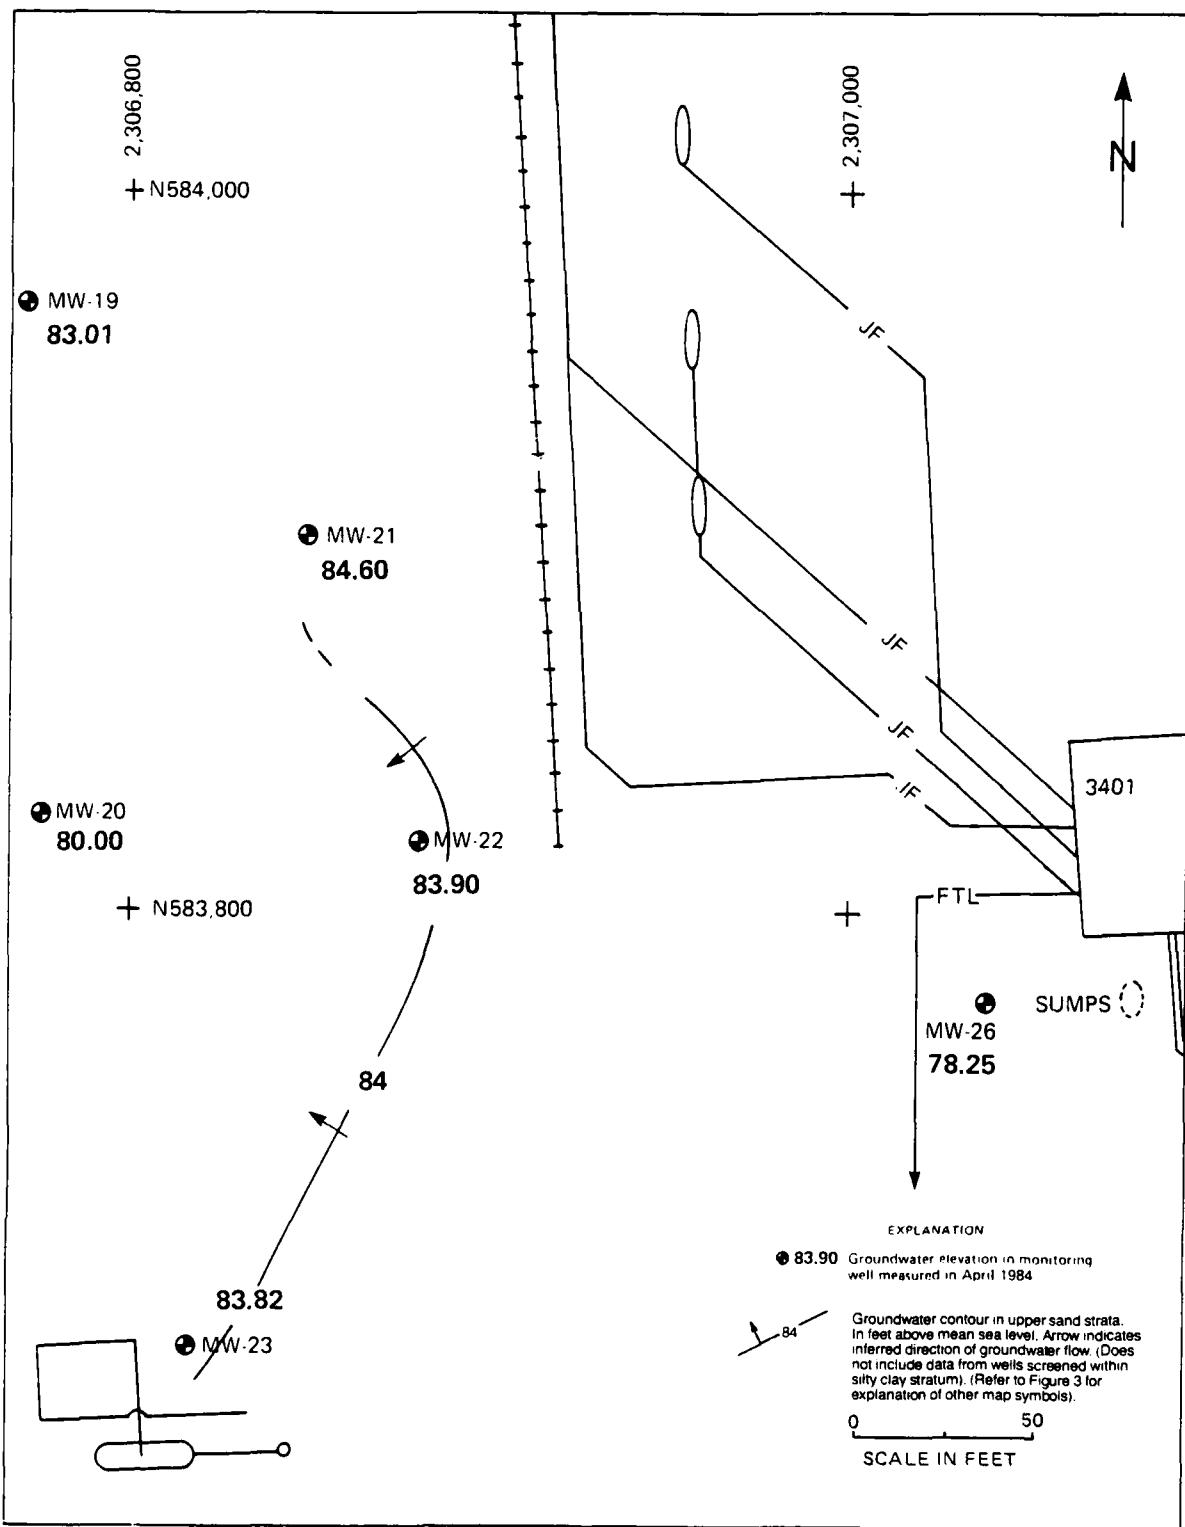
Figure 19. Groundwater elevations at Site 1 with inferred direction of flow in upper sand strata.

Groundwater quality degradation was apparent in wells MW-22 and MW-26 during well development (refer to observations of discharged groundwater in Appendix F). Groundwater produced from well MW-22 was initially noted to have an unusual deep red-brown coloration that was not noticed in any other groundwater samples on the base. When water collected during the development of well MW-22 was allowed to settle in a clear beaker, it was noted that the red-colored water separated to the bottom of the beaker and was overlain by a chocolate-brown colored water. The groundwater did not have this deep

red coloration at the time of sampling in May 1984, when the groundwater was noted to have only a pinkish hue. The soil sample collected between 9 and 12 feet in the boring for well MW-22 was also noted to have an unusual dark red-brown coloration that was not observed in any other soil samples collected on Base (Appendix C). Similarly, the fuel-oil-like odor noted in the groundwater samples from MW-26 was also detected in soil samples collected from the ground surface to a depth of 9 feet. It is significant to note that the odor was not detected deeper in MW-26 within the finer grained, clayey deposits of the Black Creek formation.

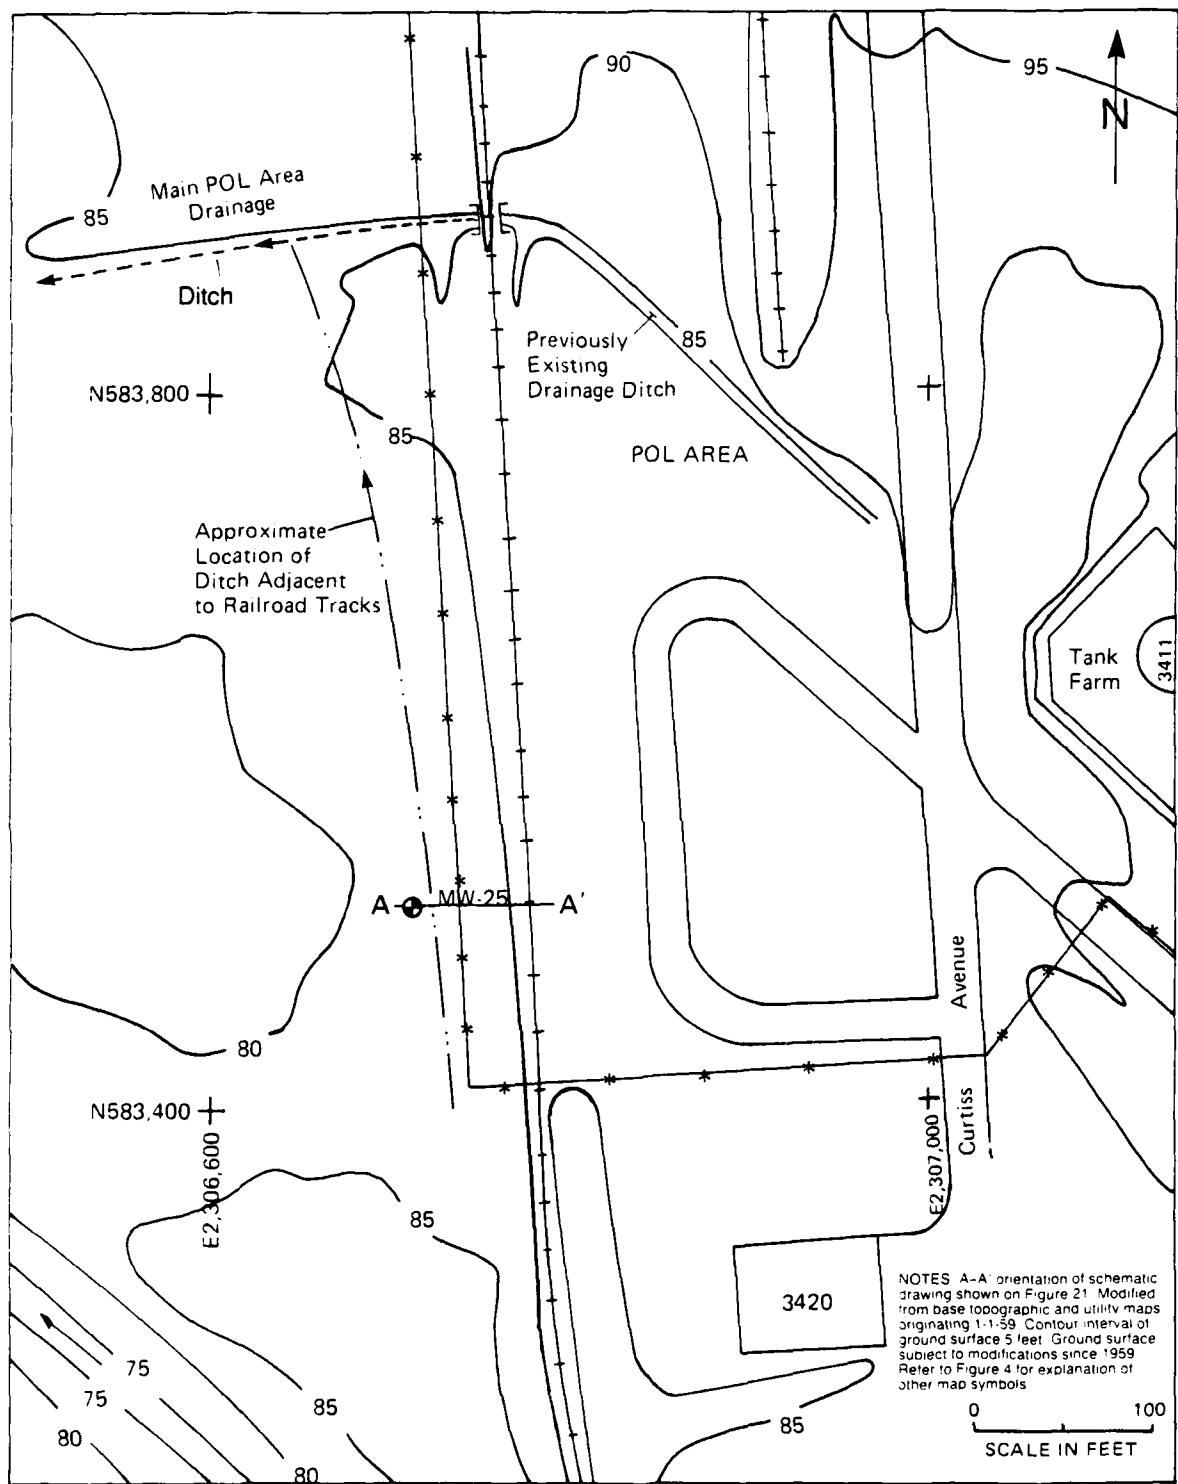
Figure 20. Topographic setting of Site 2.

The topographic setting of Site 2 is indicated in Figure 20 along with the location of an inferred hydrogeologic cross section. The ditch adjacent to the railroad tracks drains to the north into the main POL area drainage ditch. The land surface is a few feet higher east and west of the ditch.

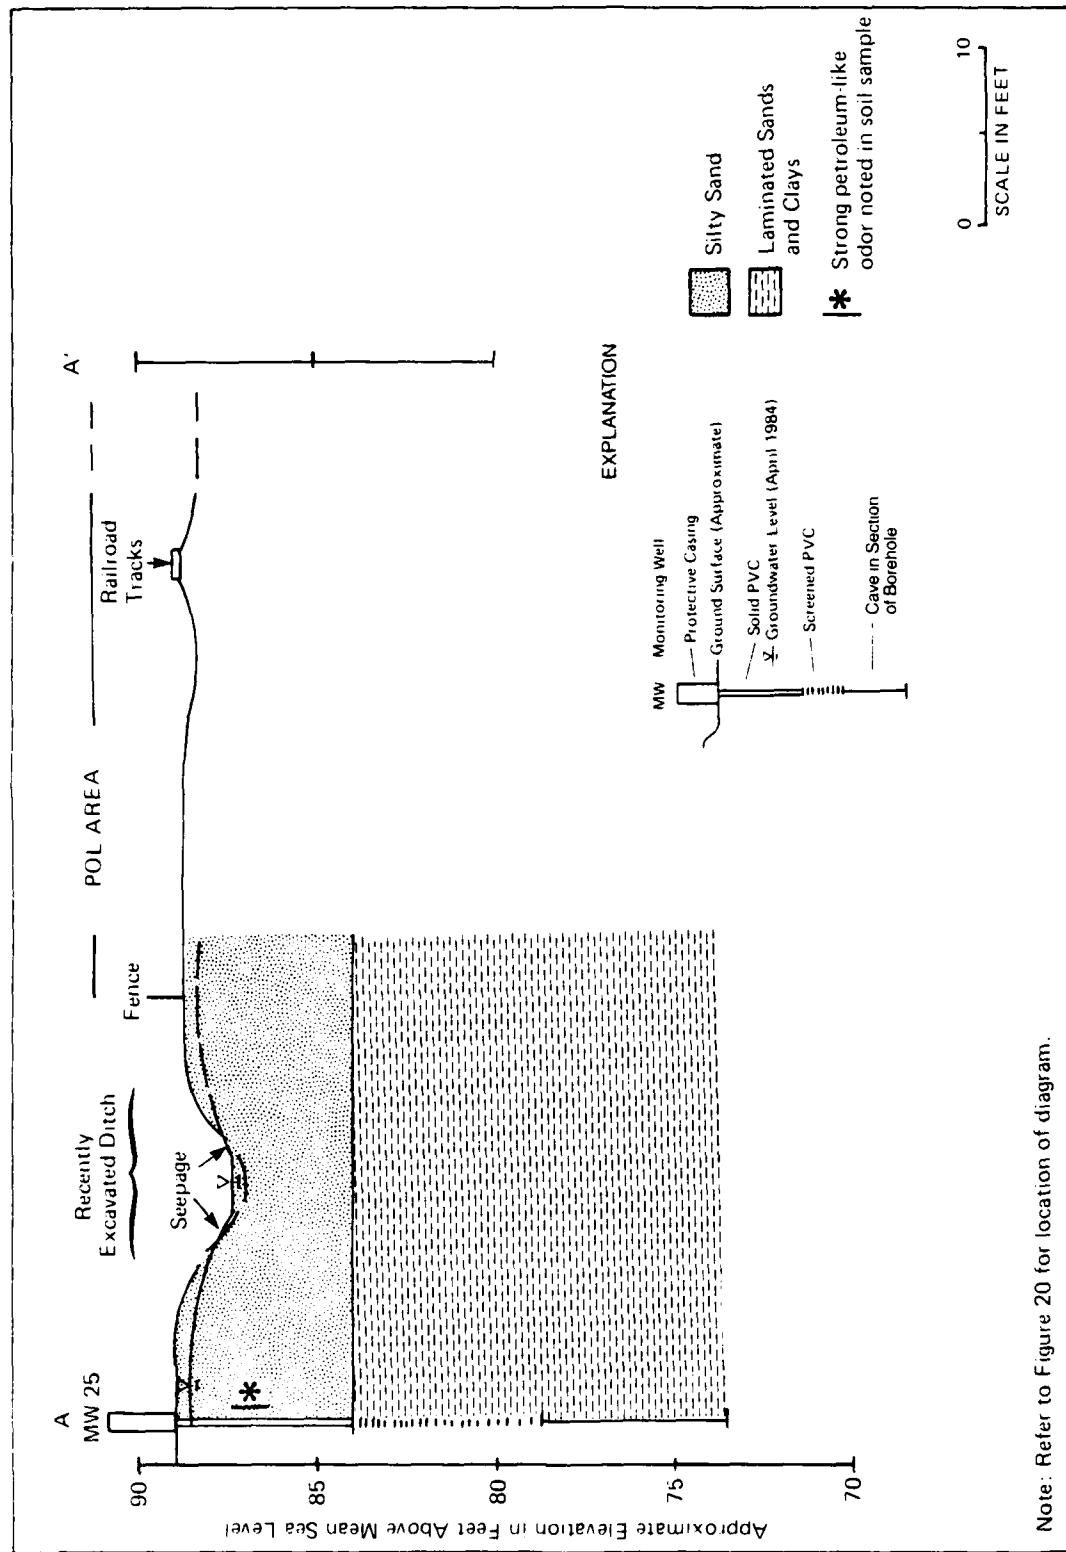
Figure 21. Schematic diagram of subsurface conditions (Site 2).

One monitoring well (MW-25) was installed at the site, and an inferred hydrogeologic cross section has been constructed on the basis of data from this well and site observations (Figure 21). The upper 5 feet of soils encountered at the site are silty fine sands (Appendix C). These soils overlie a dark gray silty clay laminated with gray silty fine sand (assumed to represent the top of the Black Creek formation).

Well MW-25 is screened just within the top of the Black Creek formation and had one of the lowest well yields estimated on the base (significantly less than 1 gal/min). Groundwater was encountered at a depth of only 0.35 feet below land surface in early April 1984 at the site (Appendix E). The drainage ditch adjacent to the railroad tracks appears to intercept groundwater flow from the east and west side based on site observations of seepage. However, this relatively shallow drainage ditch may only intercept the upper portion of groundwater flow in the surficial aquifer. Additional shallow well points would be necessary to define more completely the influence of the drainage ditch on groundwater flow conditions.
